DR-2026-1121

DAILY SITE REPORT

Sample Project · Pumping Station

21 Nov 2026

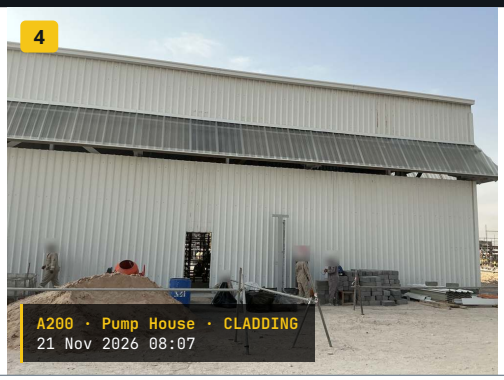
A200 Pump House 1/2

Activity	Cladding — in progress
Contractor	Contractor A (Civil) In progress · 85%
Time · place	08:05 · E 510653.3 · N 3534826.5 (38N) ±6 m
Remarks	Roof and upper cladding complete
Notes	Progress

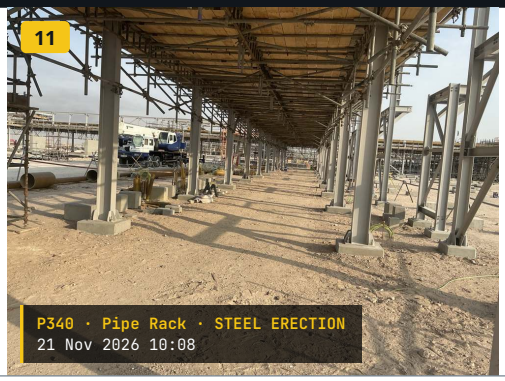
P340 Pipe Rack 1/2

Activity	Grouting — completed
Contractor	Contractor B (Mech & Piping) **In progress · 75%**
Time · place	10:05 · E 510793.3 · N 3535035.8 (38N) ±8 m
Remarks	Rack steel erected, base plates grouted
Notes	**Progress**
