DR-2026-1121

DAILY SITE REPORT

Sample Project · Pumping Station

21 Nov 2026

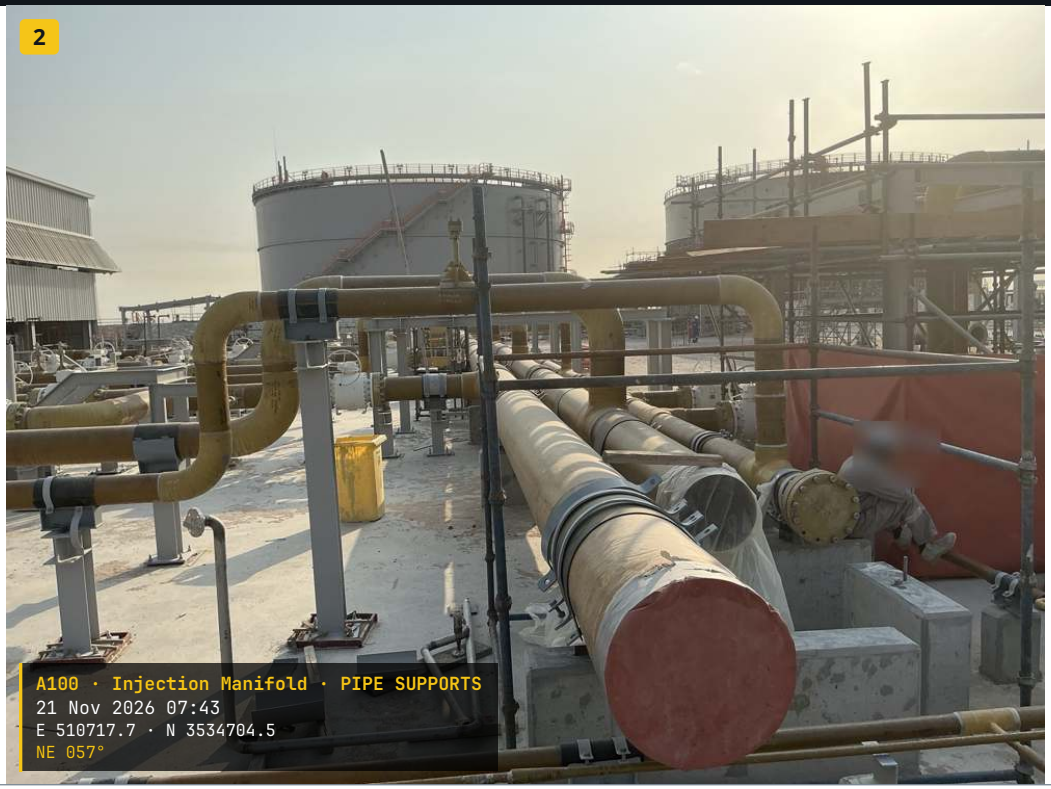
A100 Injection Manifold 1/2

Activity	Valve installation — in progress
Contractor	Contractor B (Mech & Piping) **In progress · 80%**
Time · place	07:41 · E 510685.2 · N 3535035.3 (38N) ±3 m
Remarks	GRP manifold and ball valves installed on bolted steel supports
Notes	**Progress**

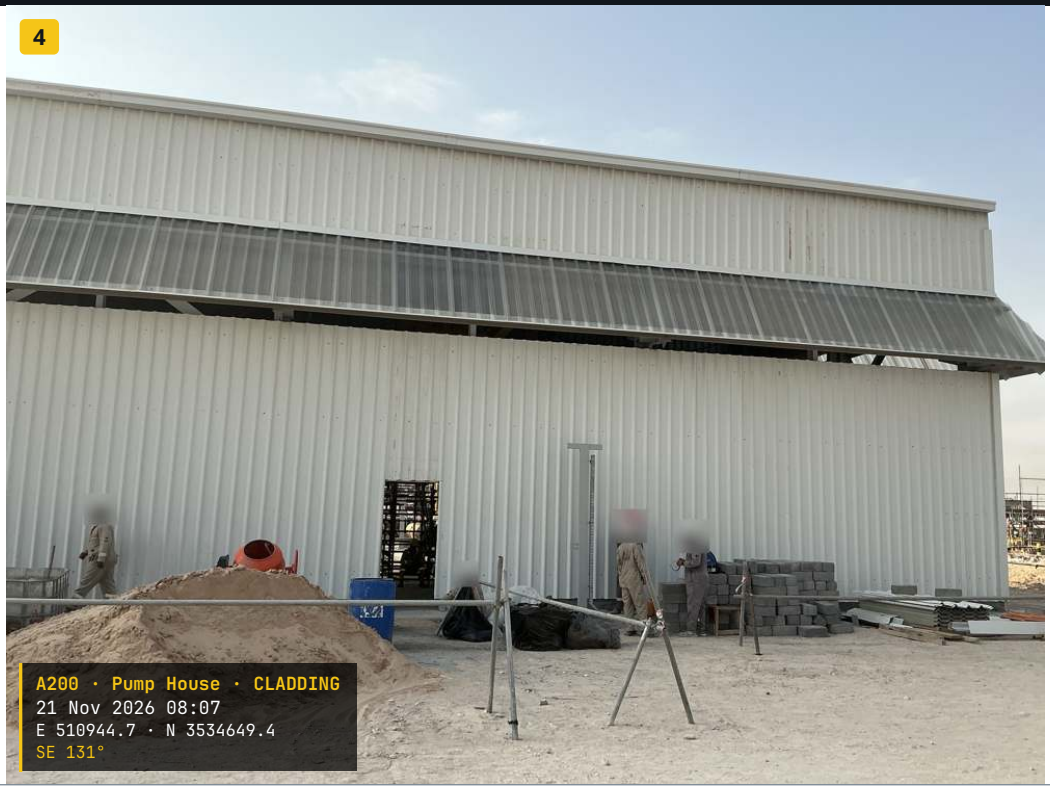
A200 Pump House

Activity	Cladding — in progress
Contractor	Contractor A (Civil) **In progress · 85%**
Time · place	08:07 · E 510944.7 · N 3534649.4 (38N) ±8 m
Remarks	East elevation fully clad
Notes	**Progress**

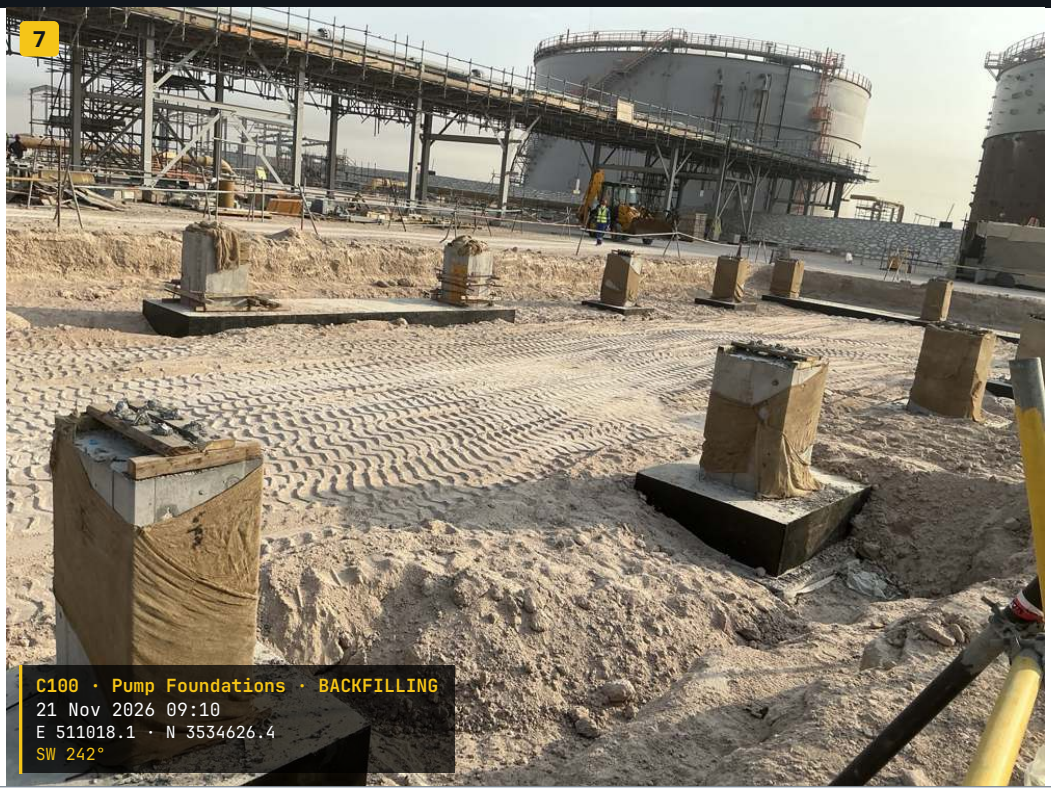
C100 Pump Foundations

Activity	Backfilling — in progress
Contractor	Contractor A (Civil) **In progress · 60%**
Time · place	09:10 · E 511018.1 · N 3534626.4 (38N) ±8 m
Remarks	ردم الطبقة الثانية حول قواعد المضخات
Notes	**Progress**

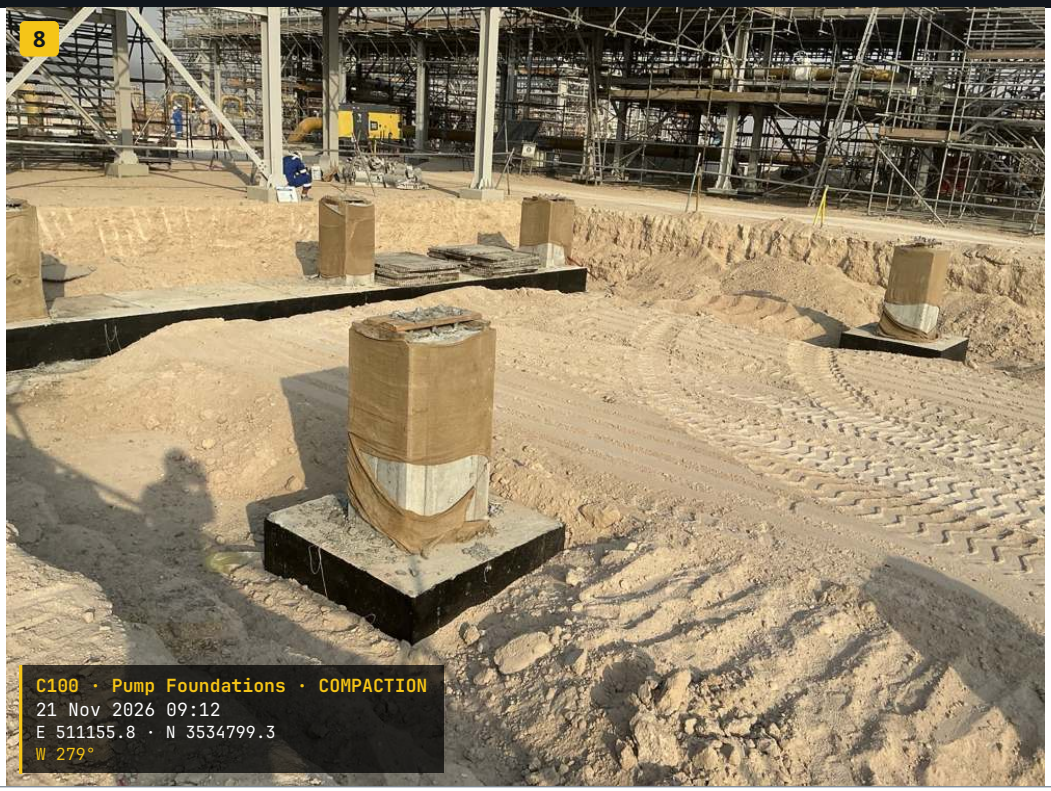
C100 Pump Foundations

Activity	Compaction — in progress
Contractor	Contractor A (Civil) **In progress · 60%**
Time · place	09:12 · E 511155.8 · N 3534799.3 (38N) ±5 m
Remarks	Compaction around pedestal footings
Notes	**Progress**

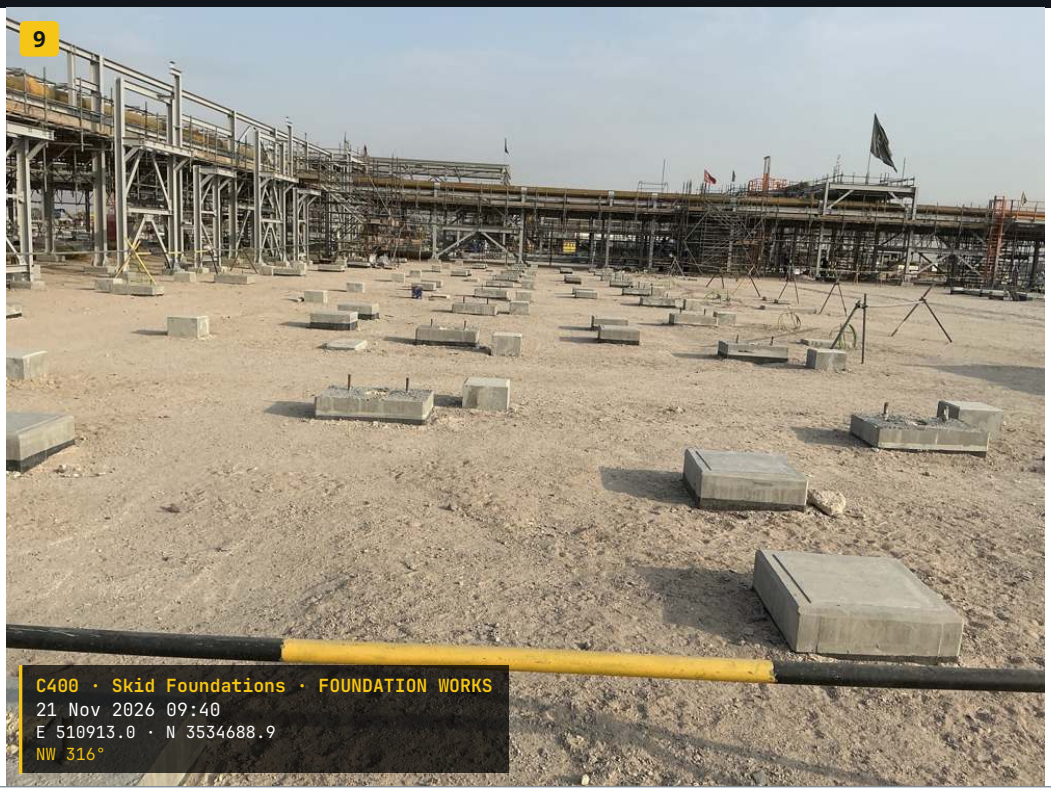
C400 Skid Foundations 1/1

Activity	Foundation works — completed
Contractor	Contractor A (Civil) Ready for next
Time · place	09:40 · E 510913.0 · N 3534688.9 (38N) ±7 m
Remarks	Skid and pipe-support foundations complete and backfilled
Notes	Ready for inspection

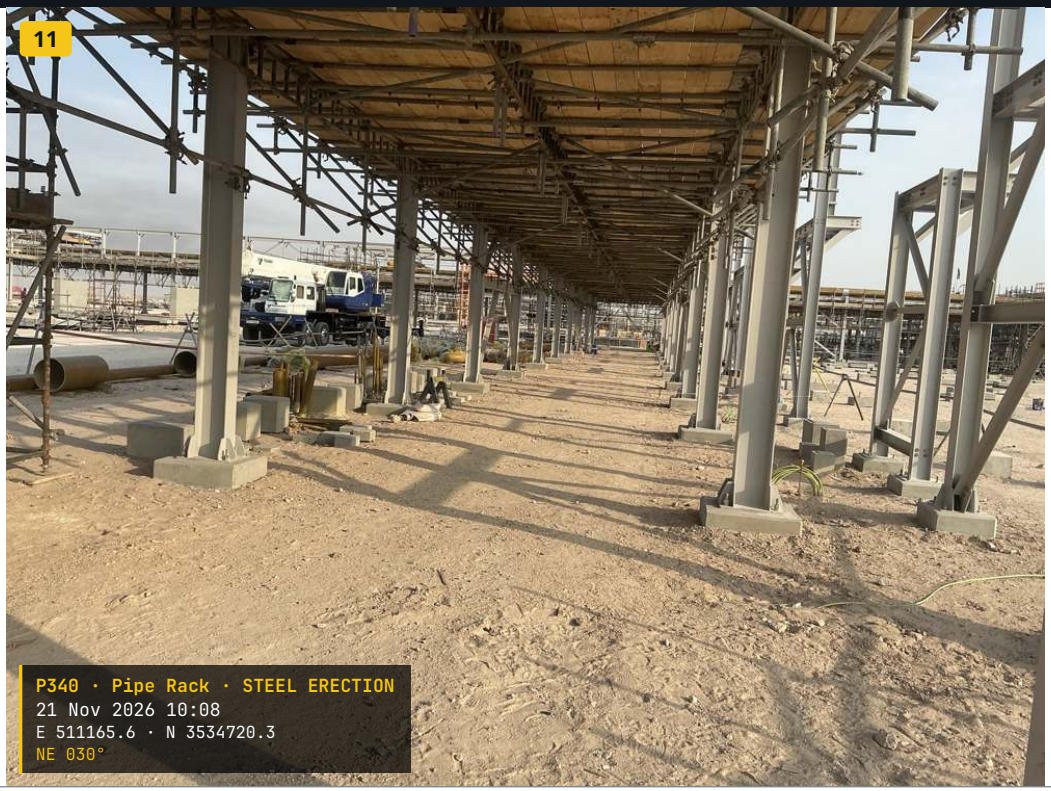
P340 Pipe Rack

Activity	Steel erection — in progress
Contractor	Contractor B (Mech & Piping) **In progress · 75%**
Time · place	10:08 · E 511165.6 · N 3534720.3 (38N) ±4 m
Remarks	Steel erected along the rack
Notes	**Progress**

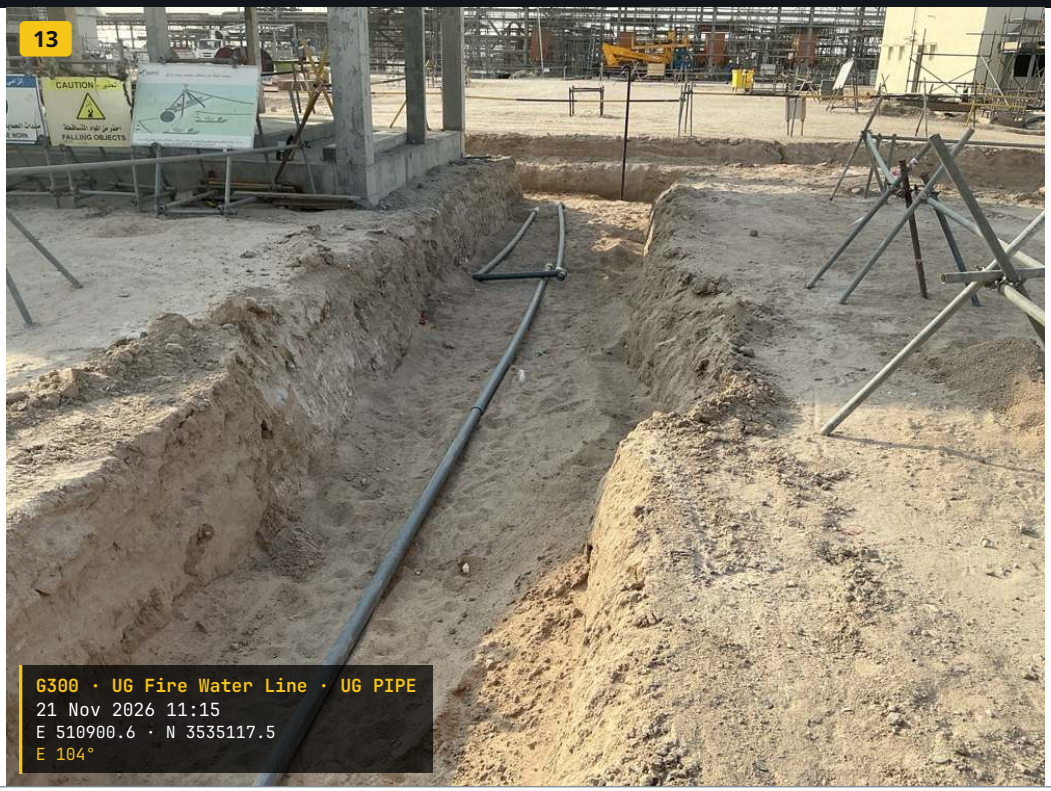
G300 UG Fire Water Line

Activity	UG pipe — in progress
Contractor	Contractor A (Civil) **In progress · 55%**
Time · place	11:15 · E 510900.6 · N 3535117.5 (38N) ±3 m
Remarks	نقطة HOLD: فحص الفرشة والمنسوب قبل الردم
Notes	**Safety**

No.	WBS	Observation	Time
S-01	E300	خندق مفتوح بدون حواجز كافية — يحتاج حواجز وإشارات	10:40
S-02	G300	نقطة HOLD: فحص الفرشة والمنسوب قبل الردم	11:15

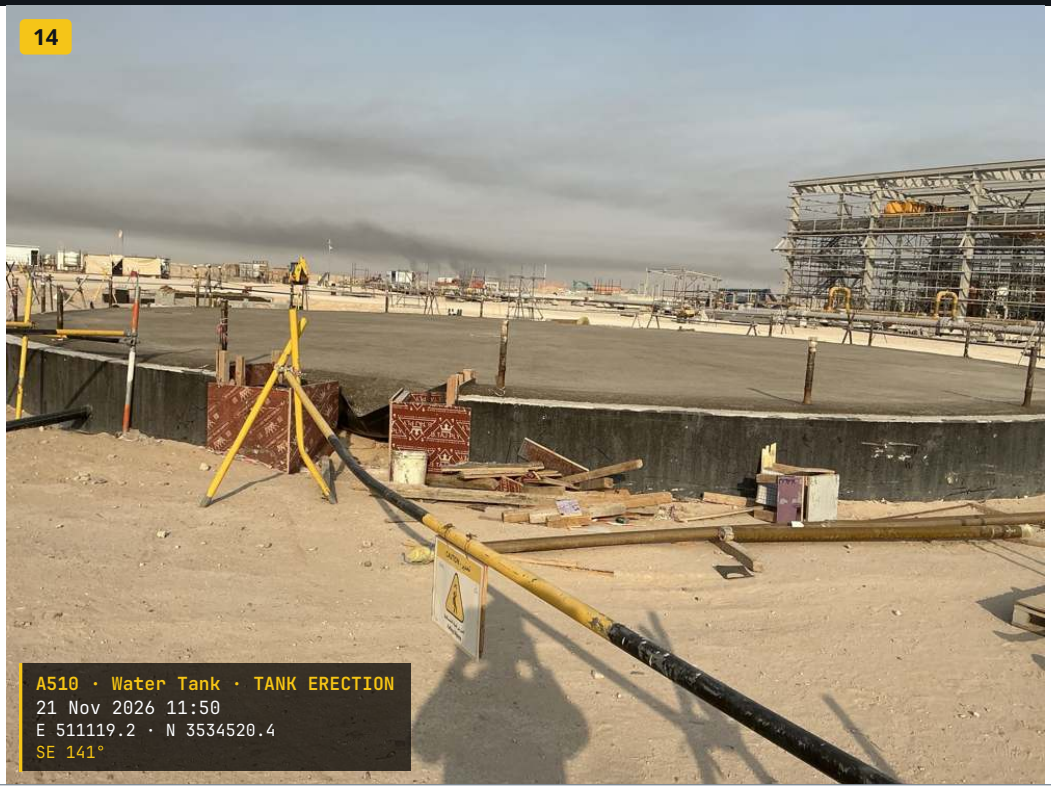
A510 Water Tank

Activity	Tank erection — completed
Contractor	Contractor B (Mech & Piping) Ready for next
Time · place	11:50 · E 511119.2 · N 3534520.4 (38N) ±6 m
Remarks	Ring wall and tank pad complete
Notes	Ready for inspection
