DR-2026-1121

DAILY SITE REPORT

Sample Project · Pumping Station

21 Nov 2026

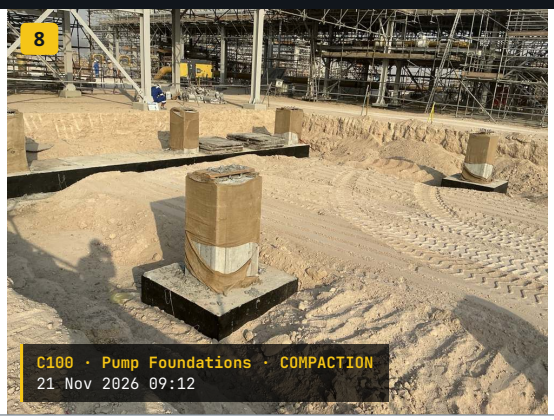
C100 Pump Foundations 1/2

Activity	Backfilling — in progress
Contractor	Contractor A (Civil) **In progress · 60%**
Time · place	09:10 · E 511018.1 · N 3534626.4 (38N) ±8 m
Remarks	ردم الطبقة الثانية حول قواعد المضخات
Notes	**Progress**

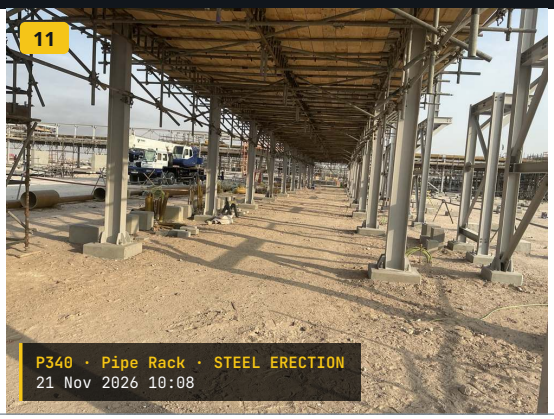
P340 Pipe Rack 1/2

Activity	Grouting — completed
Contractor	Contractor B (Mech & Piping) **In progress · 75%**
Time · place	10:05 · E 510793.3 · N 3535035.8 (38N) ±8 m
Remarks	Rack steel erected, base plates grouted
Notes	**Progress**
