Safety round

Sample Project · Pumping Station

Date	To	Prepared by	Points
21 Nov 2026	HSE Manager		4

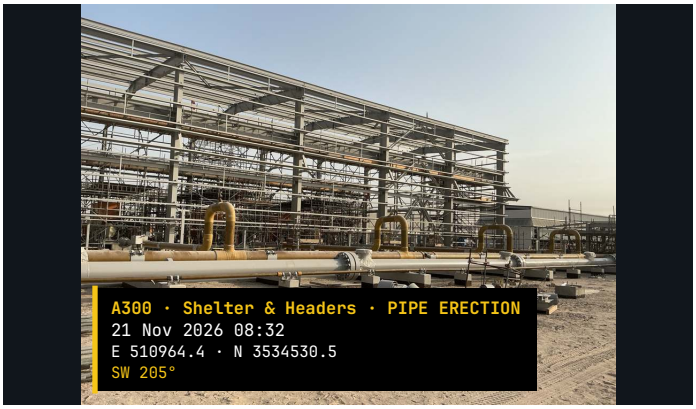
3 Shelter & headers

A300 OK

Access clear, housekeeping good.
